TECHNICAL NOTE 3190

FATIGUE INVESTIGATION OF FULL-SCALE
TRANSPORT-AIRPLANE WINGS

SUMMARY OF CONSTANT-AMPLITUDE TESTS THROUGH 1953

By M. J. McGuigan, Jr., D. F. Bryan, and R. E. Whaley

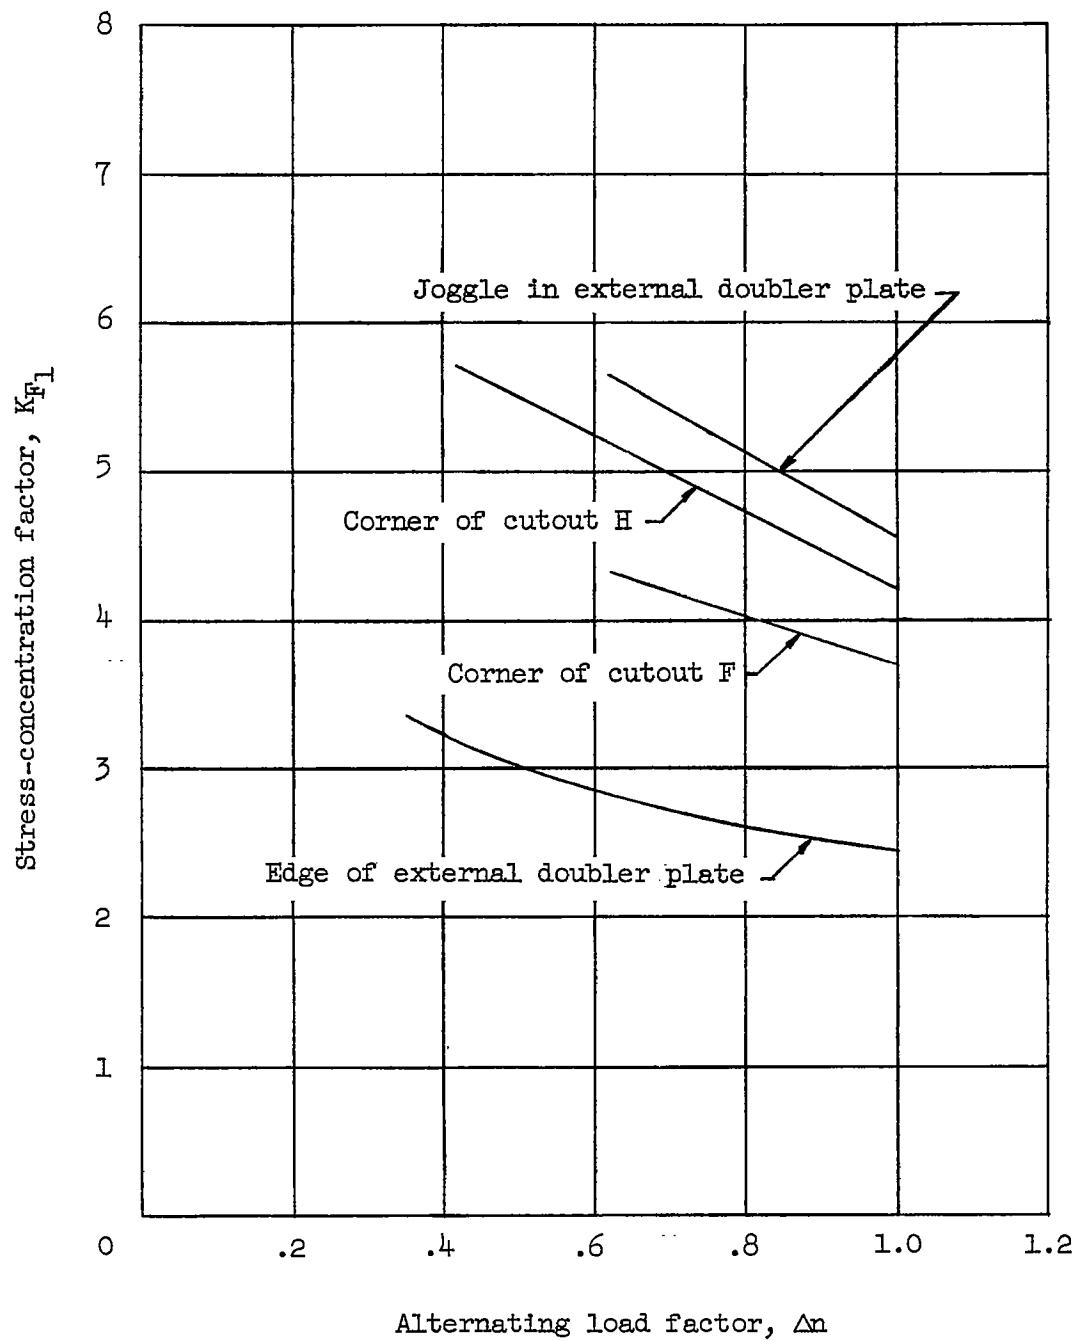
The range of concentration factor K_{F1} occurring at each load level for the five types of failures is shown in table 2. It can be noted from this table that the concentration factor tends to decrease with increasing load level. This trend is shown graphically in figure 10 for several locations where failures occurred at more than one load level. The trend is assumed to be caused by the increasing effects of plasticity associated with higher stresses as the load level is increased. Both K_{F2} and K_{F3} show the same decreasing trend with increasing load level that K_{F1} does, but in the case of K_{F3} the trend is not very apparent because of the lower magnitudes involved.

Figure 10.- Effect of load level on the stress-concentration factor.

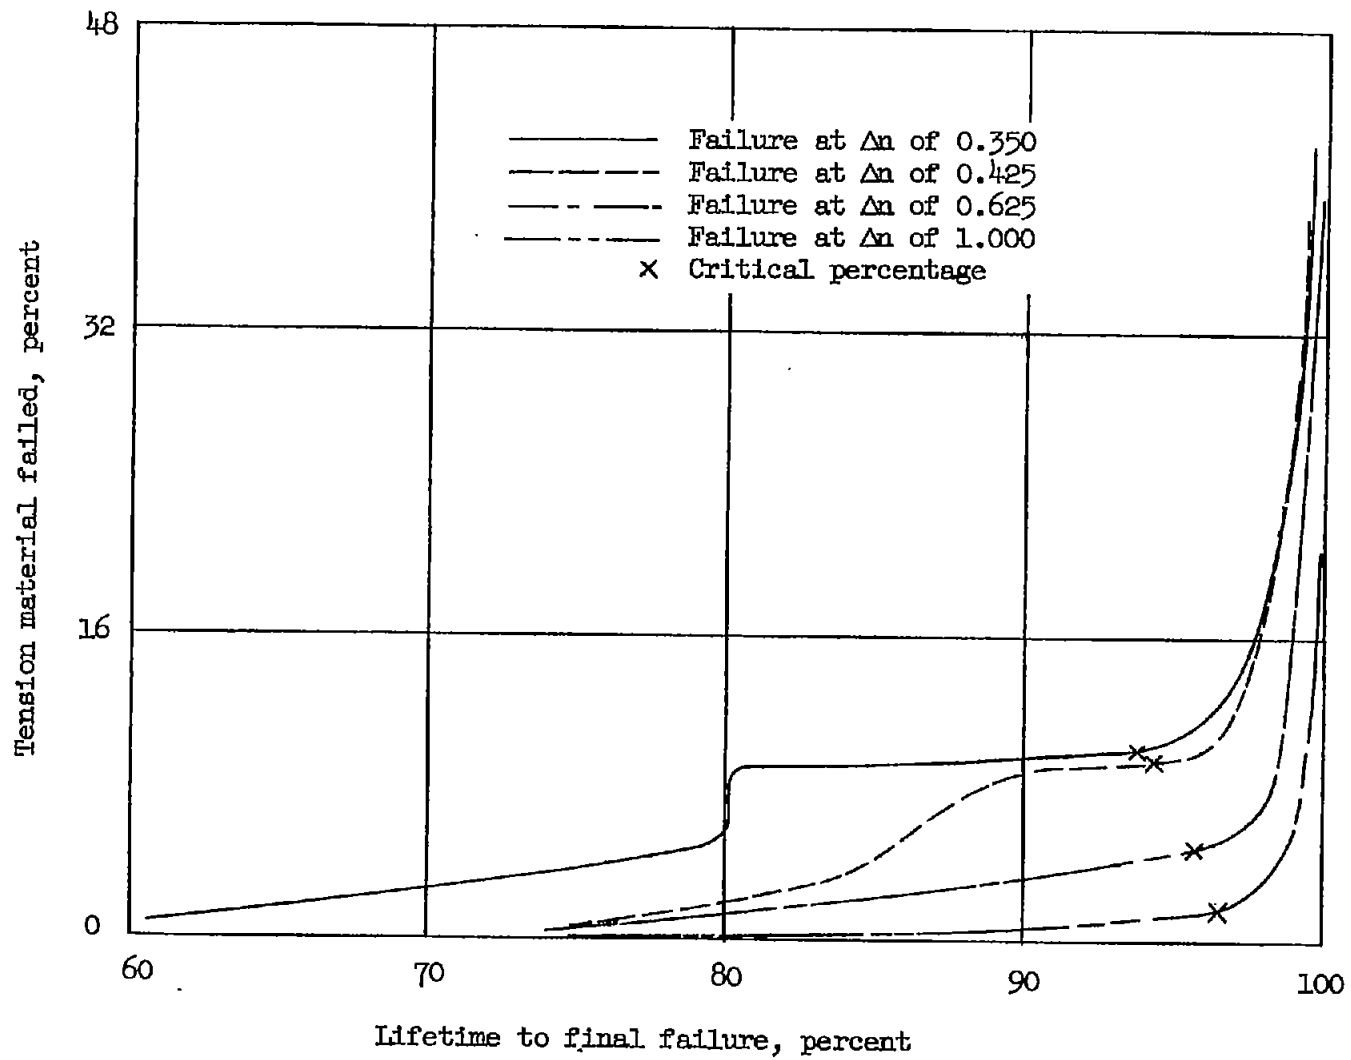
The growth of all fatigue cracks was observed during the course of the tests. In figure 11 the growth of typical failures is plotted for each of the test levels. In order to put all failures on the same comparative basis, the percentage of tension material failed in a cross section of the wing is plotted against the percentage of lifetime to final failure. In this figure it can be noted that all of the curves have the same general shape. In each case the failure grew slowly until a certain percentage of the tension material had failed. At this point, defined as the critical point, the growth of the cracks became very rapid. The percentage of tension material that had failed at the critical point decreased with increasing load level. For the 0.35g level the amount of tension material that had failed at the critical point was about 10 percent; for the 0.425g level, about 9 percent; for the 0.625g level, about 6 percent; and for the 1.0g level, about 2 percent. This critical point occurred at about 95 percent of the lifetime to final failure for all test levels. Tests of all specimens were continued until the critical point had been determined.

Figure 11.- Typical fatigue-crack propagation.

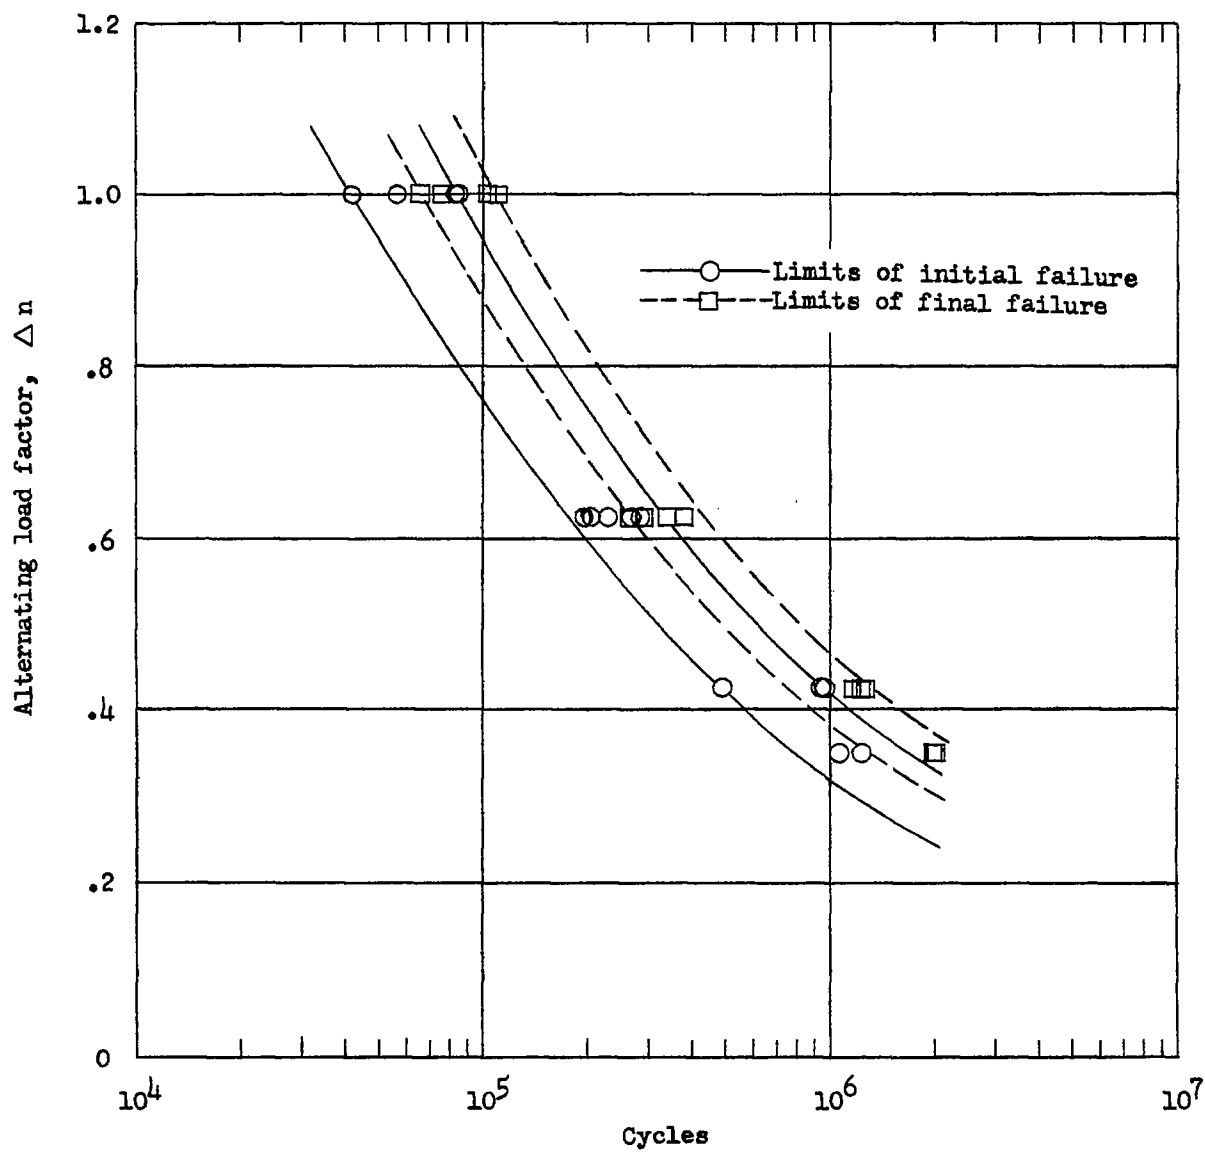
Figure 12.- Load-lifetime diagram for failures that grew past the critical point.

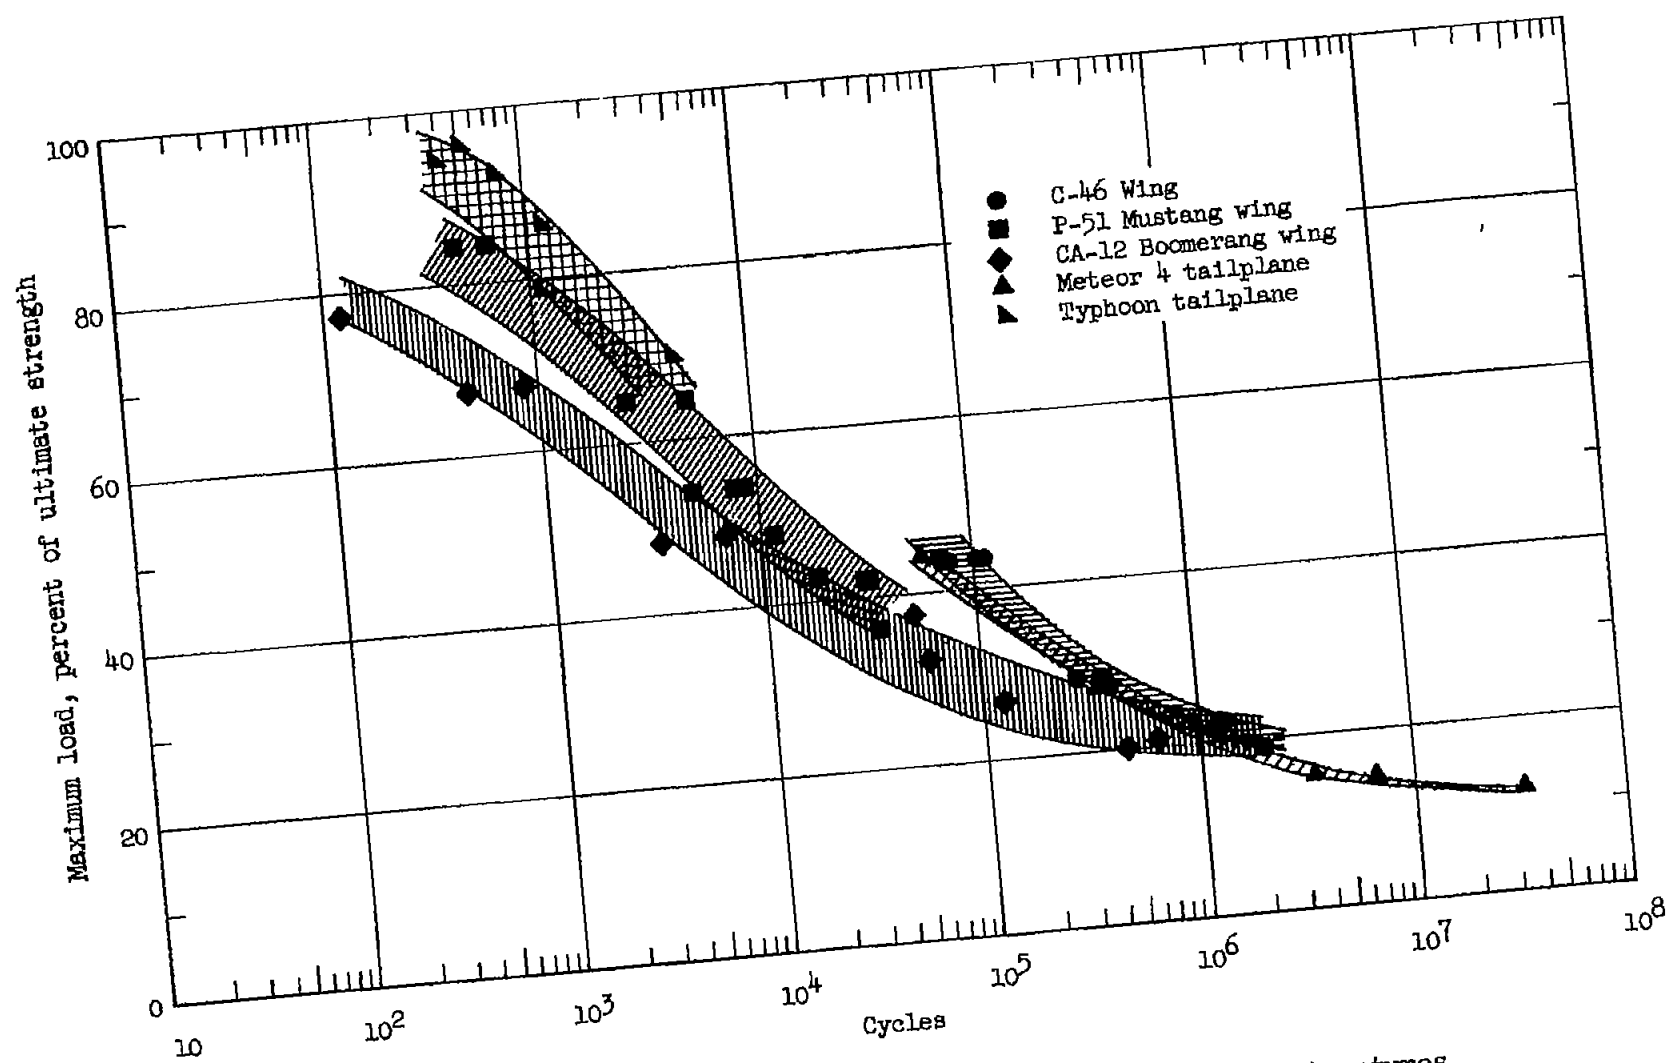
The load-lifetime diagram for final failure is presented in figure 13, along with results of fatigue tests on a number of other airplane structures taken from references 7 to 10. The load is given in percent of the ultimate static strength of the structure. It can be seen from this figure that all of the full-scale data presented lie within a comparatively narrow scatter band, considering the fact that the data include different types of airplanes and components with many types of stress raisers. Full-scale fatigue data from other airplanes have been found to fall within the scatter of the data that are presented.

Since the ordinate of figure 13 is based on the ultimate strength of the structures and since fatigue failures occurred principally on the tension surface, the load-lifetime comparison could best be made on the basis of the ultimate strength of that surface. In the static tests to determine the ultimate strength of the structures in references 7 to 10, the P-51 wing and Meteor 4 tailplane failed in compression while the remaining structures failed in tension. The C-46 curve in this figure is based on the design ultimate strength of the wing, because the actual ultimate strength is unknown. In static tests performed by the U. S. Air Force the wing failed in compression at 95 percent of the design ultimate load, and was subsequently reinforced but not retested.

If, in the case of those structures which failed in compression, the strength of the tension surface is assumed to be greater than the strength used in the comparison of figure 13, the load-lifetime curves would be shifted downward. This downward shift would very likely result in even less scatter in the data of this figure than is now present.

Figure 13.- Load-lifetime diagrams for several aircraft structures.

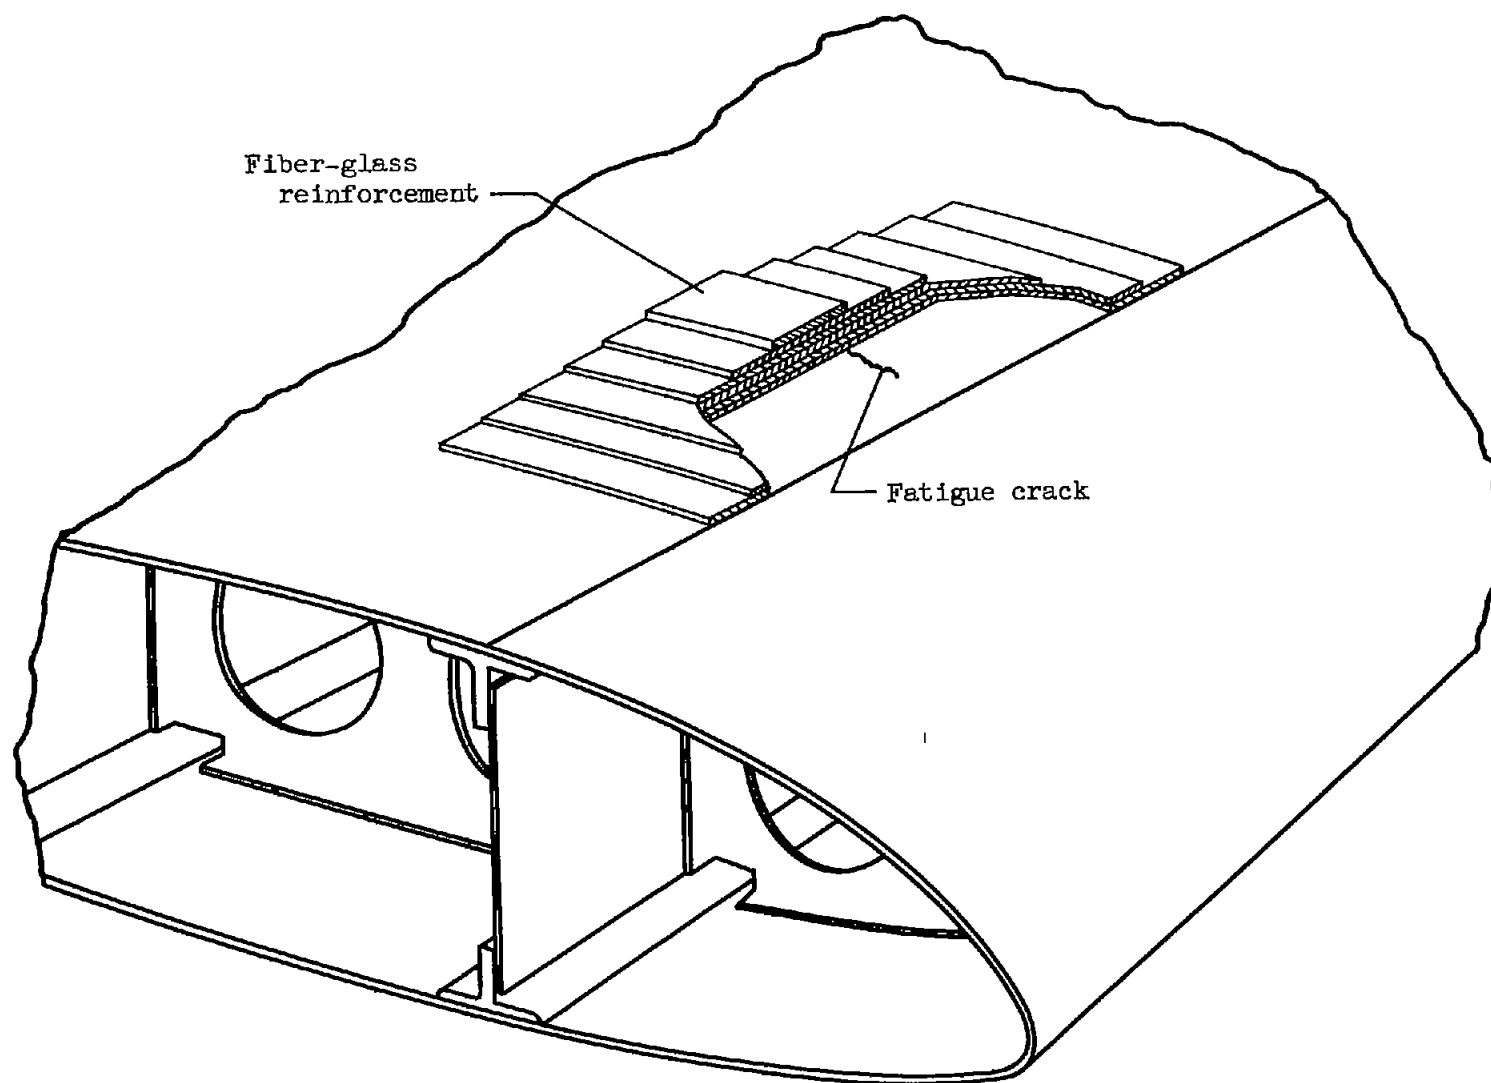
Figure 16.- Typical arrangement of fiber-glass reinforcement.

All fatigue cracks which were repaired by this method extended in essentially a chordwise direction on the tension surface of the wing. The patches were therefore designed principally to carry tension loads in a spanwise direction. For these fatigue tests the tension surface of the wing was the upper surface since the wing was mounted in the inverted position. The size of the patch required for satisfactory reinforcement naturally depended to some extent on the size of the fatigue crack to be repaired. The length and width of the reinforcement were determined by a generous estimation of the bond area necessary to secure adequate transfer of load from the wing structure to the fiber-glass reinforcement. Since the modulus of elasticity of the reinforcing material was considerably less than that of the aluminum wing structure, the thickness of reinforcement used was about five times the thickness of the structure to be repaired, so that both had about the same stiffness. All reinforcements were laminated from 10 to 16 layers of fiber-glass cloth arranged in a tapering stack which reached its maximum or design thickness over the fatigue crack. This arrangement is shown schematically in figure 16.
